Cortina Systems[®] LXT9785/LXT9785E Advanced 8-Port 10/100 Mbps PHY Tranceiver

Specification Update

Document Number 249357

Revision 13.0

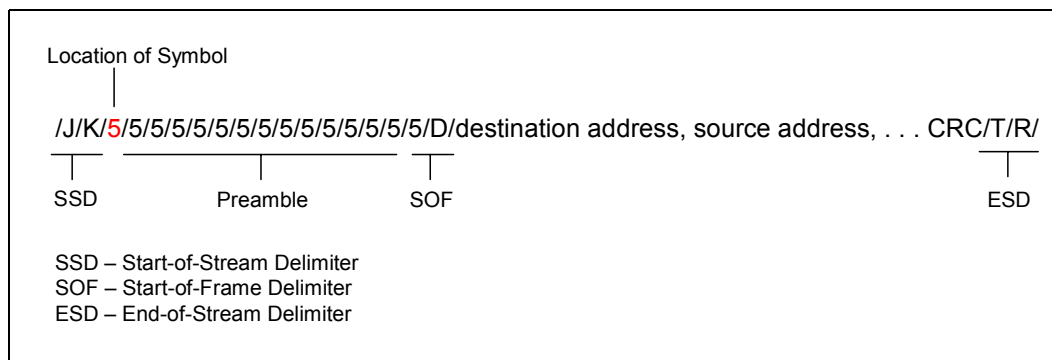
- Problem** An illegal symbol placed immediately after the SSD (preamble after JK) is not detected. However, any subsequent corrupt symbol will be detected. Below is the standard frame contents:

- Implication** RXER will not assert if this symbol location is corrupted. However, an error in this location does not affect packet integrity.
- Workaround** Use the MAC layer protocol to detect corrupt symbols in the packet.
- Status** No Fix

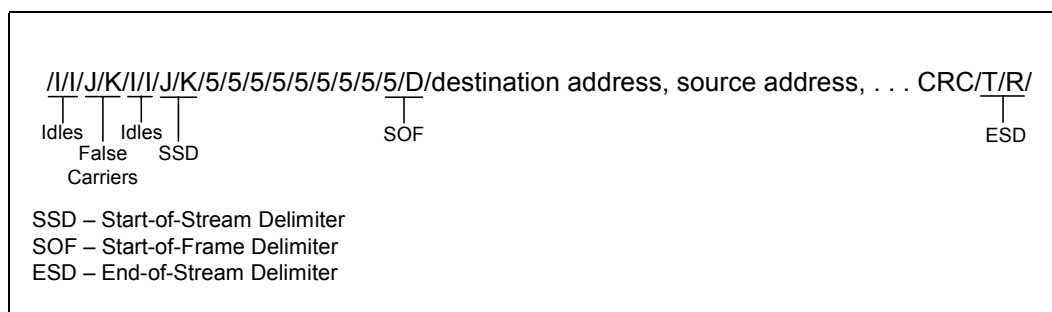
Problem A false carrier event, followed by two idle symbols and a packet, may extend the false carrier event to include the packet in 100 Mbps operation. This false carrier sequence is shown in the false carrier diagram below.

Implication A packet may be seen as a false carrier event and may be dropped. Minimal impact is expected. False carriers occur only when a large number of errors occur due to poor link quality. Below is a diagram of a false carrier:

Workaround None.
